**Flood Control Project Maintenance
Levee Inspections**

Maintenance Issue Types Only, Levee Inspection Report By Mile - Spring 2016

Tehama County Flood Control and Water Conservation District

Waterway	Bank	Unit Miles	Inspection Start/End	Inspector
Unit No. 01 Deer Creek	Left	4.22	04/26/2016 04/26/2016	Keith Millard

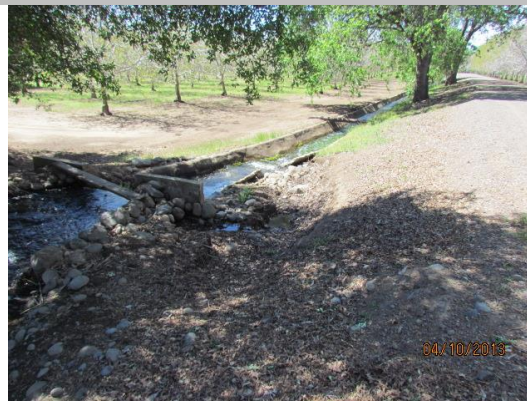
Photo 1 of 1 : SP_2016_NA0019_78_17_20160316_00009.jpg

LM Start	0.01	Rating **	M	Issue No.	17
LM End	0.01	Issue Type +	Ma	Location *	LS
Category	Earthen Levee			GPS Latitude/Longitude	
				Start	End
Item	Erosion / Bank Caving			39.973111 °	39.973111 °
				-121.980466 °	-121.980466 °
DWR ID	DWR_NA0019_01_s _ 2013_17				
Comment Code					
E1 : Note and monitor erosion site.					
Inspector Comment

View of the erosion along the landside slope.

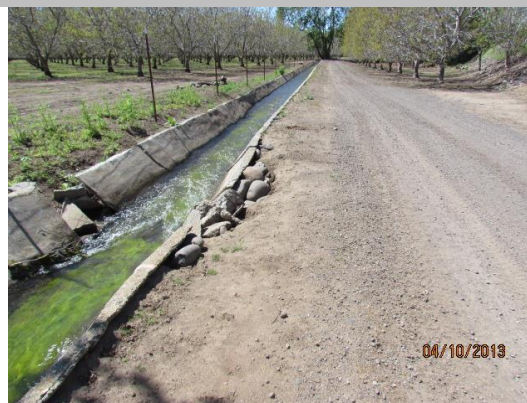
Photo 1 of 1 : SP_2016_NA0019_78_18_20160316_00010.jpg

LM Start	0.41	Rating **	M	Issue No.	18
LM End	0.41	Issue Type +	Ma	Location *	LS
Category	Earthen Levee			GPS Latitude/Longitude	
				Start	End
Item	Erosion / Bank Caving			39.972560 °	39.972560 °
				-121.987759 °	-121.987759 °
DWR ID	DWR_NA0019_01_s _ 2013_18				
Comment Code					
E1 : Note and monitor erosion site.					
Inspector Comment

View of the erosion along the landside slope.

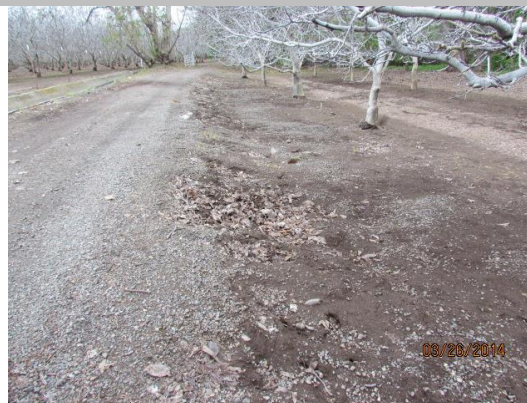
Photo 1 of 1 : SP_2016_NA0019_78_276_20160316_00018.jpg

LM Start	0.45	Rating **	M	Issue No.	276
LM End	0.45	Issue Type +	Ma	Location *	WS
Category	Earthen Levee			GPS Latitude/Longitude	
				Start	End
Item	Slope Stability			39.972377 °	39.972377 °
				-121.988559 °	-121.988559 °
DWR ID	DWR_NA0019_01_s _ 2014_276				
Comment Code					
S1 : Repair slope instability.					
Inspector Comment

View of the erosion along the waterside slope.

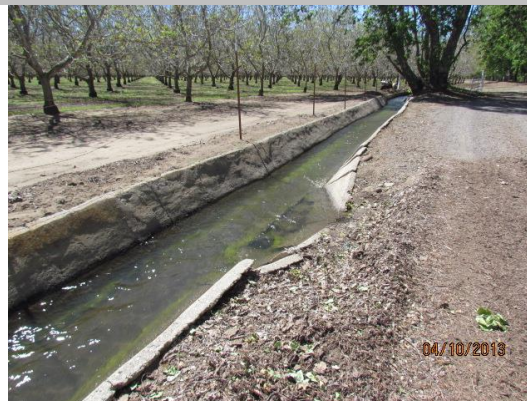
Photo 1 of 1 : SP_2016_NA0019_78_19_20160316_00011.jpg

LM Start	0.46	Rating **	M	Issue No.	19
LM End	0.46	Issue Type +	Ma	Location *	LS
Category	Earthen Levee			GPS Latitude/Longitude	
				Start	End
Item	Erosion / Bank Caving			39.972339 °	39.972339 °
				-121.988763 °	-121.988763 °
DWR ID	DWR_NA0019_01_s_2013_19				
Comment Code					
E1 : Note and monitor erosion site.					
Inspector Comment

View of the erosion along the landside slope.

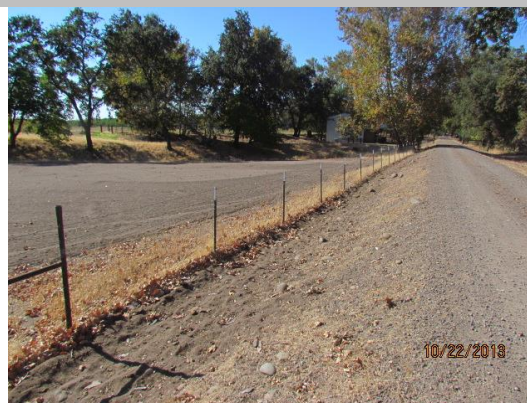
Photo 1 of 1 : SP_2016_NA0019_78_21_20160316_00013.jpg

LM Start	1.52	Rating **	M	Issue No.	21
LM End	1.52	Issue Type +	Ma	Location *	LS
Category	Earthen Levee			GPS Latitude/Longitude	
				Start	End
Item	Animal Control			39.969419 °	39.969419 °
				-122.007850 °	-122.007850 °
DWR ID	DWR_NA0019_01_f_2013_21				
Comment Code					
A2 : Repair the levee slope damaged by livestock and prevent large animal access.					
Inspector Comment

View of the erosion caused by livestock on both slope of the levee.

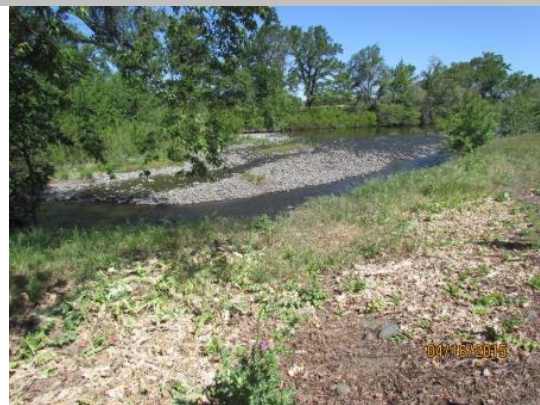
Photo 1 of 1 : SP_2016_NA0019_78_39_20160316_00016.jpg

LM Start	2.78	Rating **	M	Issue No.	39
LM End	2.78	Issue Type +	Ma	Location *	WS
Category	Earthen Levee			GPS Latitude/Longitude	
				Start	End
Item	Erosion / Bank Caving			39.964772 °	39.964772 °
				-122.029023 °	-122.029023 °
DWR ID	DWR_NA0019_01_s _ 2015_39				
Comment Code					
E1 : Note and monitor erosion site.					
Inspector Comment					
Monitor the erosion during high water.

View of the erosion along the waterside toe.

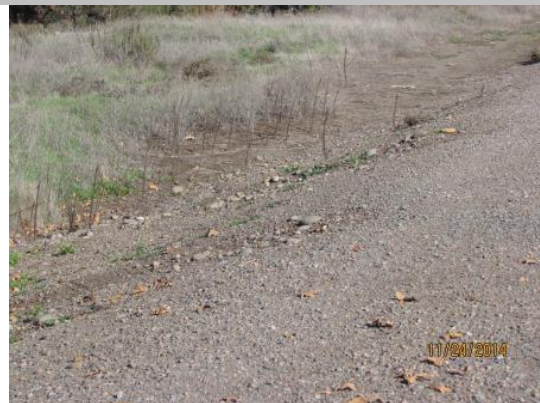
Photo 1 of 1 : SP_2016_NA0019_78_38_20160316_00015.jpg

LM Start	2.86	Rating **	M	Issue No.	38
LM End	2.86	Issue Type +	Ma	Location *	LS
Category	Earthen Levee			GPS Latitude/Longitude	
				Start	End
Item	Slope Stability			39.963928 °	39.963928 °
				-122.030120 °	-122.030120 °
DWR ID	DWR_NA0019_01_f_2014_38				
Comment Code					
S1 : Repair slope instability.					
Inspector Comment

View of erosion from the cattle on both slopes.

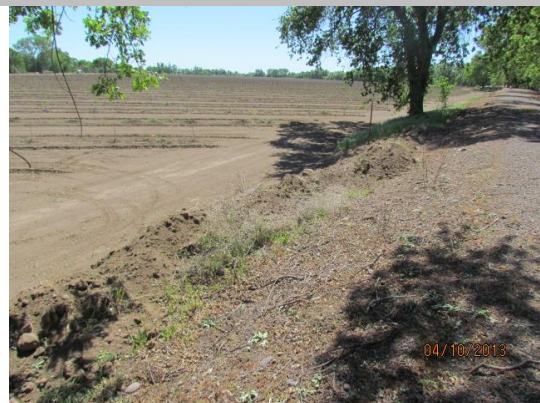
Photo 1 of 1 : SP_2016_NA0019_78_20_20160316_00012.jpg

LM Start	2.88	Rating **	M	Issue No.	20
LM End	2.88	Issue Type +	Ma	Location *	LS
Category	Earthen Levee			GPS Latitude/Longitude	
				Start	End
Item	Slope Stability			39.963709 °	39.963709 °
				-122.030384 °	-122.030384 °
DWR ID	DWR_NA0019_01_s_2013_20				
Comment Code					
S1 : Repair slope instability.					
Inspector Comment

View of the erosion along the landside slope.

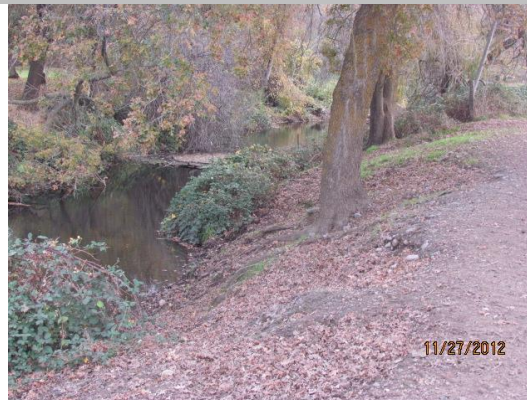
Photo 1 of 1 : SP_2016_NA0019_78_15_20160316_00007.jpg

LM Start	3.68	Rating **	M	Issue No.	15
LM End	3.68	Issue Type +	Ma	Location *	WS
Category	Earthen Levee			GPS Latitude/Longitude	
				Start	End
Item	Slope Stability			39.945045 °	39.945045 °
				-122.053469 °	-122.053469 °
DWR ID	DWR_NA0019_01_f_2012_15				
Comment Code					
S1 : Repair slope instability.					
Inspector Comment

View of the erosion caused by livestock along the landside slope.

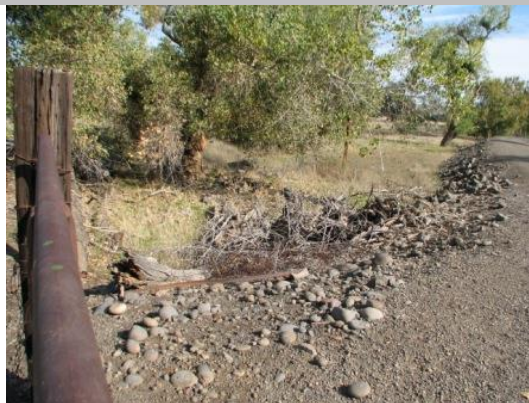
Photo 1 of 1 : SP_2016_NA0019_79_2_20160316_00001.jpg

LM Start	0.30	Rating **	M	Issue No.	2
LM End	0.30	Issue Type +	Ma	Location *	LS
Category	Earthen Levee			GPS Latitude/Longitude	
				Start	End
Item	Encroachments			39.970305 °	39.970305 °
				-122.014465 °	-122.014465 °
DWR ID	DWR_NA0019_02_s _ 2012_2				
Comment Code					
DE : Debris					
Inspector Comment

View of debris & wire at toe of levee.

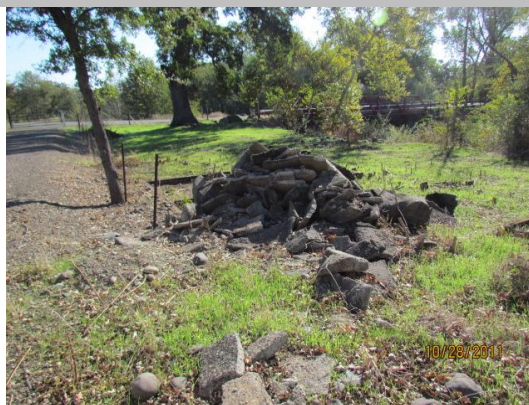
Photo 1 of 1 : SP_2016_NA0019_79_4_20160316_00003.jpg

LM Start	0.34	Rating **	M	Issue No.	4
LM End	0.34	Issue Type +	Ma	Location *	WS
Category	Earthen Levee			GPS Latitude/Longitude	
				Start	End
Item	Encroachments			39.970210 °	39.970210 °
				-122.015198 °	-122.015198 °
DWR ID	DWR_NA0019_02_s _ 2012_4				
Comment Code					
DE : Debris					
Inspector Comment

View of the concrete pile along the W/S toe.

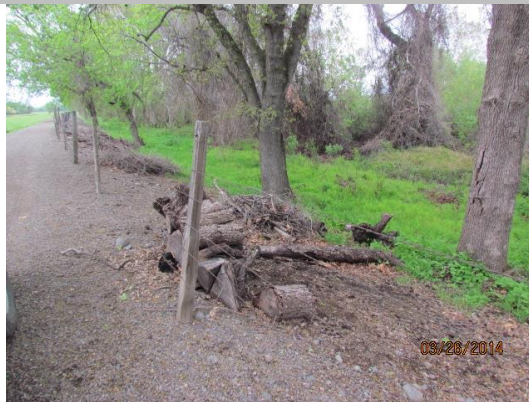
Photo 1 of 1 : SP_2016_NA0019_79_6_20160316_00004.jpg

LM Start	1.28	Rating **	M	Issue No.	6
LM End	1.28	Issue Type +	Ma	Location *	WS
Category	Earthen Levee			GPS Latitude/Longitude	
				Start	End
Item	Encroachments			39.964883 °	39.964883 °
				-122.030655 °	-122.030655 °
DWR ID	DWR_NA0019_02_s _ 2012_6				
Comment Code					
FW : Firewood					
Inspector Comment

Remove all firewood from the waterside slope.

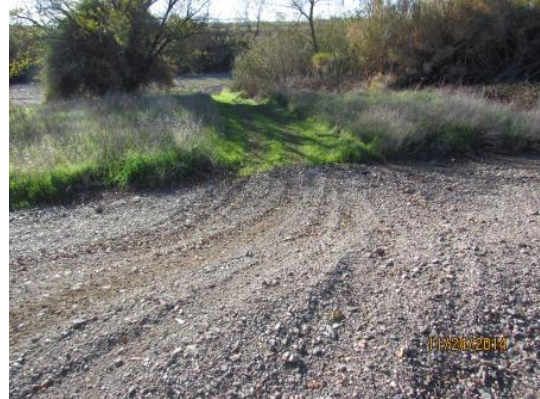
Photo 1 of 1 : SP_2016_NA0019_81_16_20160316_00011.jpg

LM Start	1.39	Rating **	M	Issue No.	16
LM End	1.39	Issue Type +	Ma	Location *	WS
Category	Earthen Levee			GPS Latitude/Longitude	
				Start	End
Item	Slope Stability			40.051493 °	40.051493 °
				-122.164935 °	-122.164935 °
DWR ID	DWR_NA0019_04_f_2014_16				
Comment Code					
S3 : Repair the levee slope damaged by vehicle traffic and prevent access where possible.					
Inspector Comment

View of the vehicle erosion along the waterside slope.

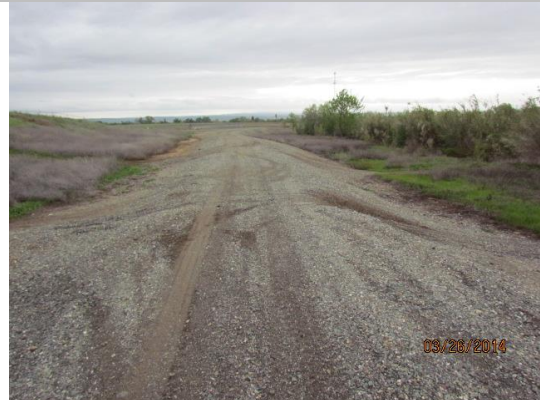
Photo 1 of 1 : SP_2016_NA0019_81_3_20160316_00003.jpg

LM Start	1.59	Rating **	M	Issue No.	3
LM End	1.69	Issue Type +	Ma	Location *	WS
Category	Earthen Levee			GPS Latitude/Longitude	
				Start	End
Item	Slope Stability			40.052607 °	40.053558 °
				-122.161418 °	-122.159903 °
DWR ID	DWR_04_s_2012_3				
Comment Code					
S3 : Repair the levee slope damaged by vehicle traffic and prevent access where possible.					
Inspector Comment					
Tehama Co. repaired the slope that was damaged by vehicle traffic, but the damage has returned. On 4/26/16, vehicle erosion area was repaired again, but should be monitored.

View of the levee slope damaged by vehicle traffic.

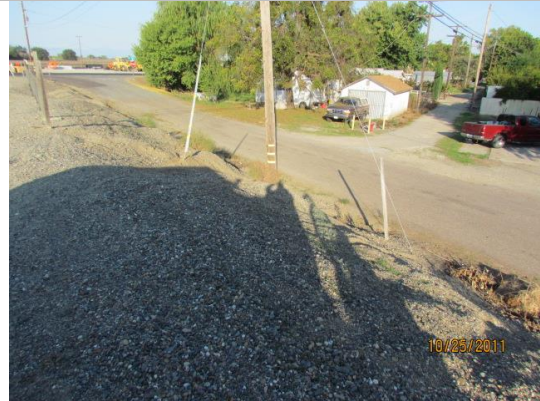
Photo 1 of 1 : SP_2016_NA0019_81_18_20160316_00013.jpg

LM Start	2.30	Rating **	M	Issue No.	18
LM End	2.30	Issue Type +	Ma	Location *	LS
Category	Earthen Levee			GPS Latitude/Longitude	
				Start	End
Item	Slope Stability			40.052415 °	40.052415 °
				-122.149208 °	-122.149208 °
DWR ID	DWR_NA0019_04_s_2012_18				
Comment Code					
S3 : Repair the levee slope damaged by vehicle traffic and prevent access where possible.					
Inspector Comment

View of the vehicle erosion along the L/S slope.

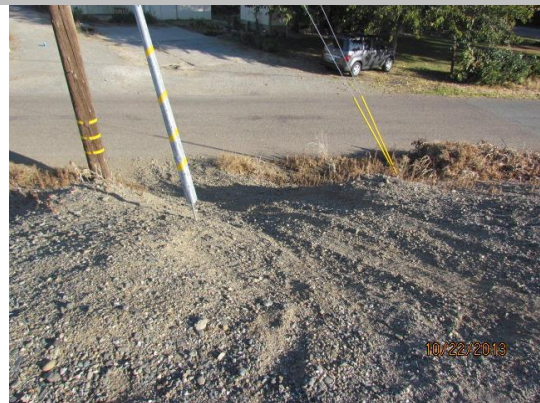
Photo 1 of 1 : SP_2016_NA0019_81_12_20160316_00007.jpg

LM Start	2.32	Rating **	M	Issue No.	12
LM End	2.32	Issue Type +	Ma	Location *	LS
Category	Earthen Levee			GPS Latitude/Longitude	
				Start	End
Item	Slope Stability			40.052443 °	40.052443 °
				-122.148863 °	-122.148863 °
DWR ID	DWR_NA0019_04_f_2013_12				
Comment Code					
S3 : Repair the levee slope damaged by vehicle traffic and prevent access where possible.					
Inspector Comment

View of the vehicle erosion along the landside slope.

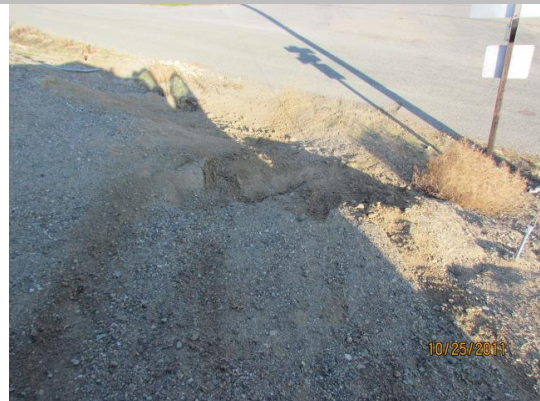
Photo 1 of 1 : SP_2016_NA0019_81_20_20160316_00015.jpg

LM Start	2.43	Rating **	M	Issue No.	20
LM End	2.43	Issue Type +	Ma	Location *	LS
Category	Earthen Levee			GPS Latitude/Longitude	
				Start	End
Item	Slope Stability			40.052417 °	40.052417 °
				-122.146747 °	-122.146747 °
DWR ID	DWR_NA0019_04_s_2012_20				
Comment Code					
S3 : Repair the levee slope damaged by vehicle traffic and prevent access where possible.					
Inspector Comment

View of the vehicle erosion along the L/S slope.

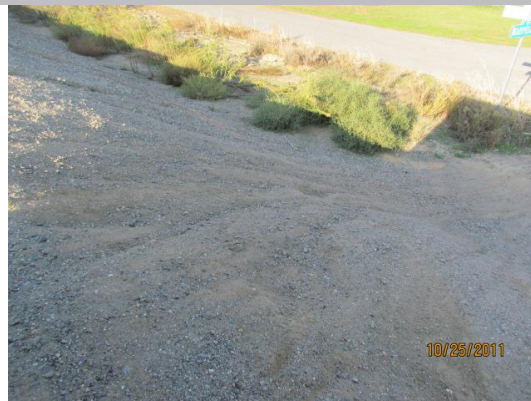
Photo 1 of 1 : SP_2016_NA0019_81_2_20160316_00002.jpg

LM Start	2.51	Rating **	M	Issue No.	2
LM End	2.51	Issue Type +	Ma	Location *	LS
Category	Earthen Levee			GPS Latitude/Longitude	
				Start	End
Item	Slope Stability			40.052872 °	40.052872 °
				-122.145495 °	-122.145495 °
DWR ID	DWR_NA0019_04_s _ 2012_2				
Comment Code					
S3 : Repair the levee slope damaged by vehicle traffic and prevent access where possible.					
Inspector Comment

View of the vehicle erosion along the L/S slope.

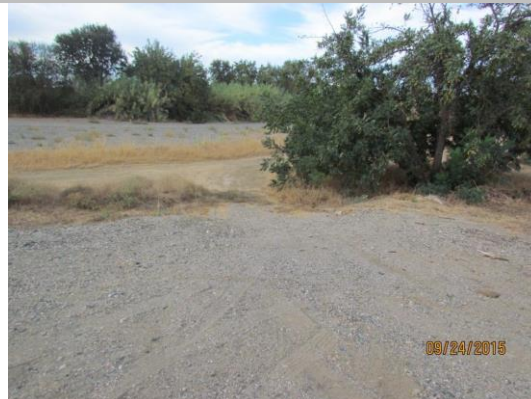
Photo 1 of 1 : SP_2016_NA0019_81_10_20160316_00005.jpg

LM Start	3.01	Rating **	M	Issue No.	10
LM End	3.01	Issue Type +	Ma	Location *	WS
Category	Earthen Levee			GPS Latitude/Longitude	
				Start	End
Item	Slope Stability			40.056388 °	40.056388 °
				-122.139168 °	-122.139168 °
DWR ID	DWR_NA0019_04_s_2012_10				
Comment Code					
S3 : Repair the levee slope damaged by vehicle traffic and prevent access where possible.					
Inspector Comment					
Repair the waterside slope from vehicle erosion.

View of the vehicle erosion along the waterside slope.

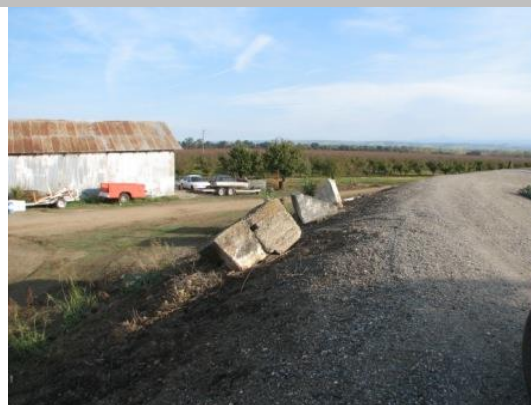
Photo 1 of 1 : SP_2016_NA0019_81_1_20160316_00001.jpg

LM Start	3.13	Rating **	M	Issue No.	1
LM End	3.13	Issue Type +	Ma	Location *	LS
Category	Earthen Levee			GPS Latitude/Longitude	
				Start	End
Item	Encroachments			40.057285 °	40.057285 °
				-122.137732 °	-122.137732 °
DWR ID	DWR_NA0019_04_s_2012_1				
Comment Code					
ST : Stairway					
Inspector Comment					
Remove concnere blocks, concrete pipes and concrete stairs from the landside slope.

View of the concrete stairways on the slope.

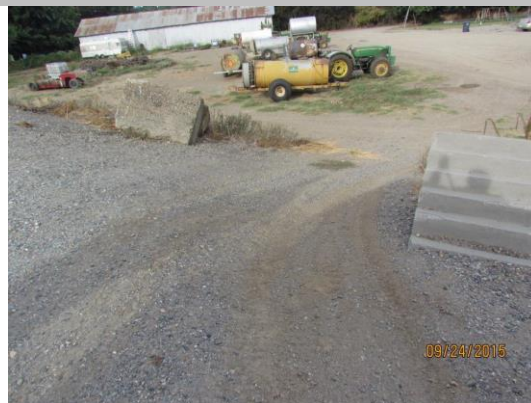
Photo 1 of 1 : SP_2016_NA0019_81_25_20160316_00020.jpg

LM Start	3.13	Rating **	M	Issue No.	25
LM End	3.13	Issue Type +	Ma	Location *	LS
Category	Earthen Levee			GPS Latitude/Longitude	
				Start	End
Item	Slope Stability			40.057350 °	40.057350 °
				-122.137667 °	-122.137667 °
DWR ID	DWR_NA0019_04_f_2015_25				
Comment Code					
S3 : Repair the levee slope damaged by vehicle traffic and prevent access where possible.					
Inspector Comment					
Repair the landside slope from vehicle erosion.

View of the vehicle erosion along the landside slope.

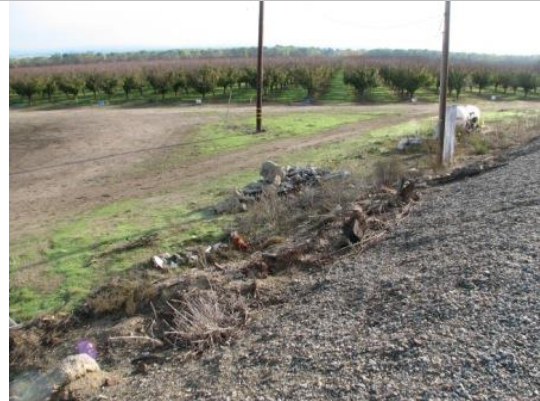
Photo 1 of 1 : SP_2016_NA0019_81_6_20160316_00004.jpg

View of the garbage and metal along the landside slope and toe of the levee.

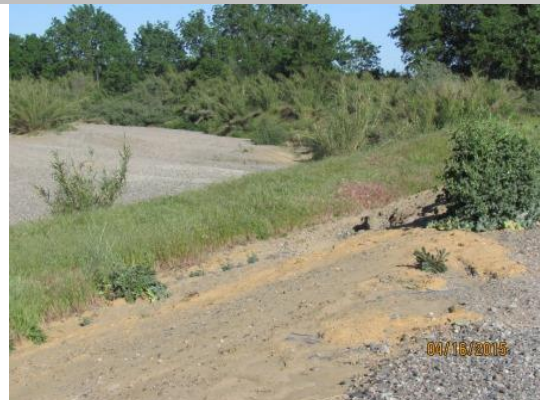
Photo 1 of 1 : SP_2016_NA0019_81_23_20160316_00018.jpg

LM Start	3.78	Rating **	U	Issue No.	23
LM End	3.89	Issue Type +	Ma	Location *	WS
Category	Earthen Levee			GPS Latitude/Longitude	
				Start	End
Item	Erosion / Bank Caving			40.055207 °	40.054225 °
				-122.127735 °	-122.126085 °
DWR ID	DWR_NA0019_04_s _ 2015_23				
Comment Code					
E2 : Schedule repair of erosion site prior to the next inspection.					
Inspector Comment					
Repair the erosion along the waterside slope. Overtopped in 2014. DWR FSRP repair contract in place per LMA on 4/26/2016.

View of the erosion along the waterside slope.

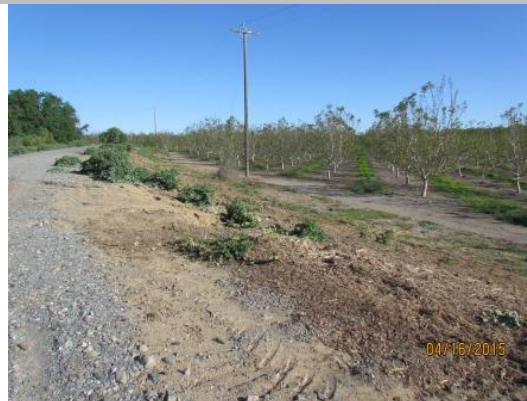
Photo 1 of 1 : SP_2016_NA0019_81_22_20160316_00017.jpg

LM Start	3.78	Rating **	U	Issue No.	22
LM End	3.93	Issue Type +	Ma	Location *	LS
Category	Earthen Levee			GPS Latitude/Longitude	
				Start	End
Item	Erosion / Bank Caving			40.055162 °	40.053915 °
				-122.127713 °	-122.125412 °
DWR ID	DWR_NA0019_04_s _ 2015_22				
Comment Code					
E2 : Schedule repair of erosion site prior to the next inspection.					
Inspector Comment					
Repair the erosion along the landside slope. Overtopped in 2014. DWR FSRP repair contract in place per LMA on 4/26/2016.

View of the erosion along the landside slope.

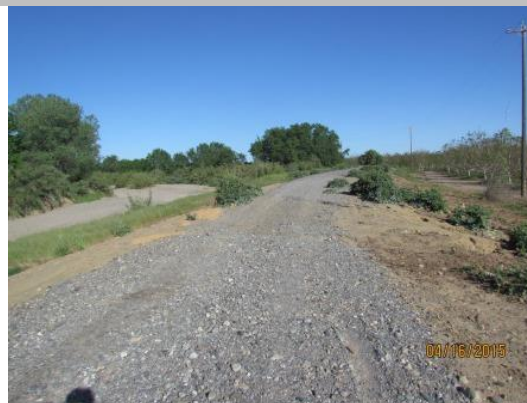
Photo 1 of 1 : SP_2016_NA0019_81_24_20160316_00019.jpg

LM Start	3.79	Rating **	U	Issue No.	24
LM End	3.93	Issue Type +	Ma	Location *	CR
Category	Earthen Levee			GPS Latitude/Longitude	
				Start	End
Item	Erosion / Bank Caving			40.055060 °	40.053917 °
				-122.127602 °	-122.125412 °
DWR ID	DWR_NA0019_04_s _ 2015_24				
Comment Code					
E2 : Schedule repair of erosion site prior to the next inspection.					
Inspector Comment					
Repair the erosion on the crown roadway. Overtopped in 2014. DWR FSRP repair contract in place per LMA on 4/26/2016.

View of the erosion on the crown roadway.

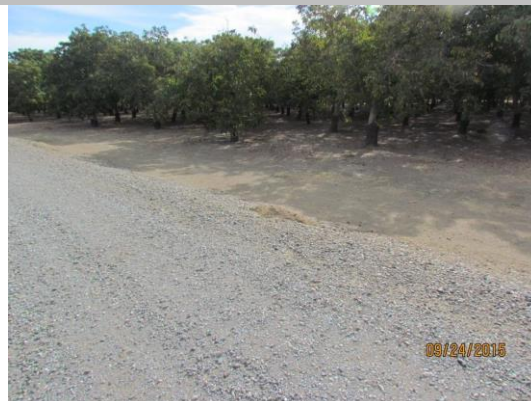
Photo 1 of 1 : SP_2016_NA0019_82_8_20160316_00003.jpg

View of the rodent holes along the landside slope.

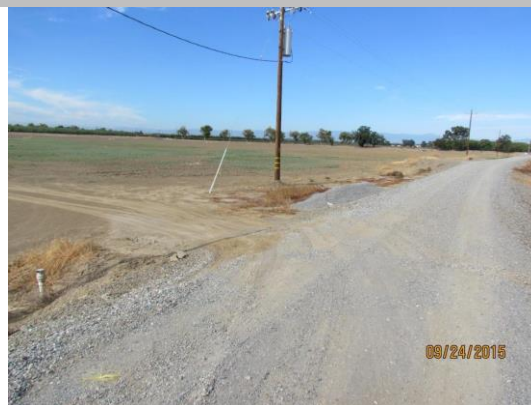
Photo 1 of 1 : SP_2016_NA0019_82_13_20160316_00004.jpg

LM Start	1.51	Rating **	A/W	Issue No.	13
LM End	1.51	Issue Type +	Ma	Location *	LS
Category	Earthen Levee			GPS Latitude/Longitude	
				Start	End
Item	Slope Stability			40.050653 °	40.050653 °
				-122.165495 °	-122.165495 °
DWR ID	DWR_NA0019_05_f_2015_13				
Comment Code					
S3 : Repair the levee slope damaged by vehicle traffic and prevent access where possible.					
Inspector Comment					
Repair the vehicle erosion long the landside slope. On 4/26/16 no damage was observed on levee. Should be monitored.

View of the vehicle erosion along the landside slope.

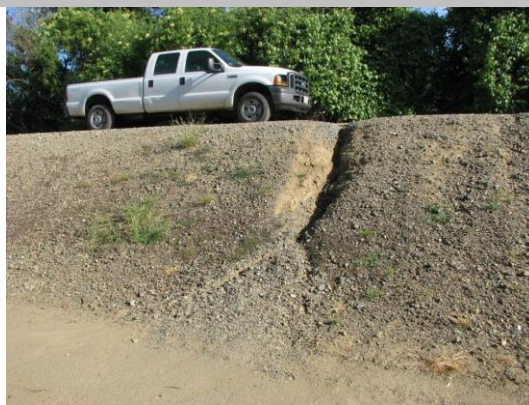
Photo 1 of 1 : SP_2016_NA0019_82_10_20160506_00016.jpg

LM Start	3.35	Rating **	U	Issue No.	10
LM End	3.35	Issue Type +	Ma	Location *	LS
Category	Earthen Levee			GPS Latitude/Longitude	
				Start	End
Item	Erosion / Bank Caving			40.056875 °	40.056875 °
				-122.135349 °	-122.135349 °
DWR ID	DWR_NA0019_05_s _ 2016_10				
Comment Code					
E2 : Schedule repair of erosion site prior to the next inspection.					
Inspector Comment					
Erosion rut running down LS slope from crown to toe

04/26/2016: Erosional rutting on L/S slope.

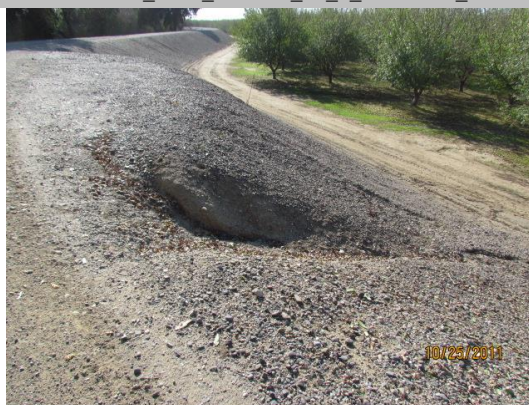
Photo 1 of 1 : SP_2016_NA0019_82_7_20160316_00002.jpg

LM Start	3.38	Rating **	U	Issue No.	7
LM End	3.38	Issue Type +	Ma	Location *	LS
Category	Earthen Levee			GPS Latitude/Longitude	
				Start	End
Item	Erosion / Bank Caving			40.056727 °	40.056727 °
				-122.134888 °	-122.134888 °
DWR ID	DWR_NA0019_05_s _ 2016_7				
Comment Code					
E2 : Schedule repair of erosion site prior to the next inspection.					
Inspector Comment

View of the erosion along the L/S slope.
